FOUNTAIN CREEK REACH 2
&
FIELDS PARK

PROJECT ASSESSMENT AND RESTORATION DESIGN DOCUMENT

Aquatic Assessment
&
Habitat Enhancement Plan
Fountain Creek - The Fields Park
City of Manitou Springs
El Paso County - Colorado

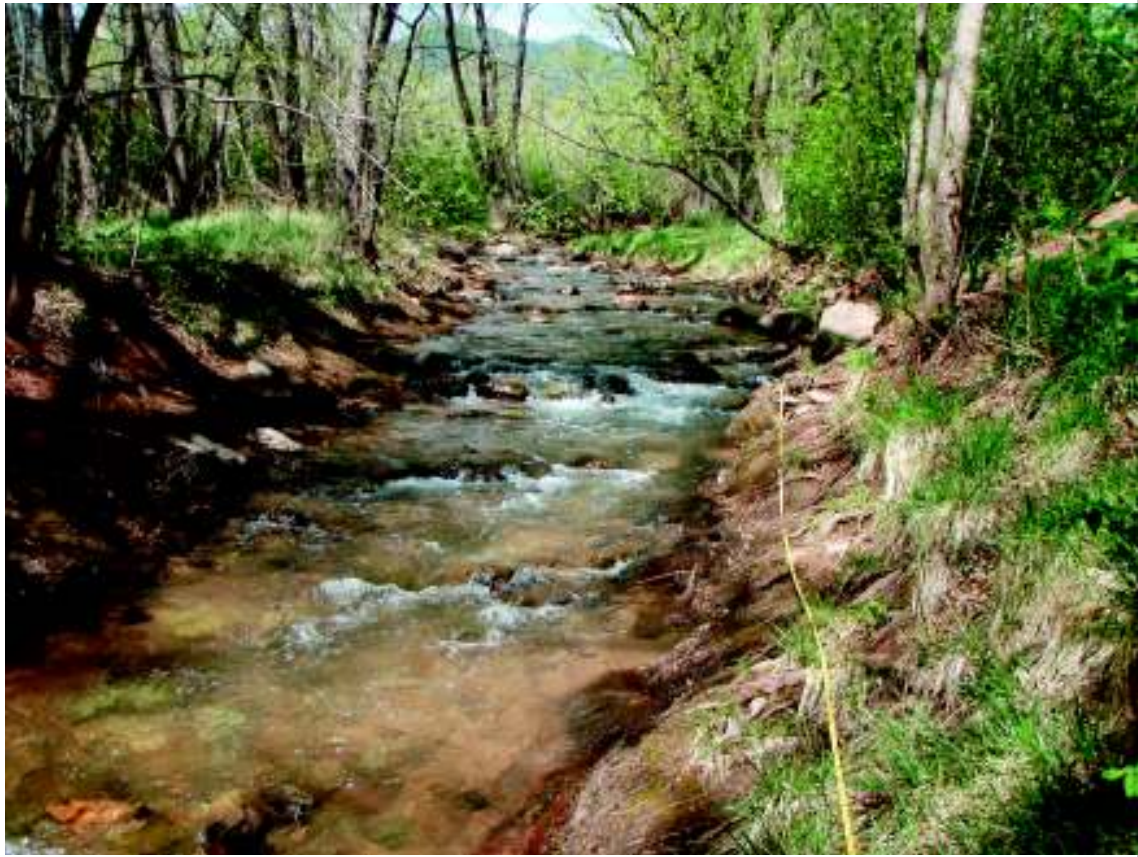
Photo 2: Typical Cobble Riffle (Riffle #4) on Reach 2 of Fountain Creek

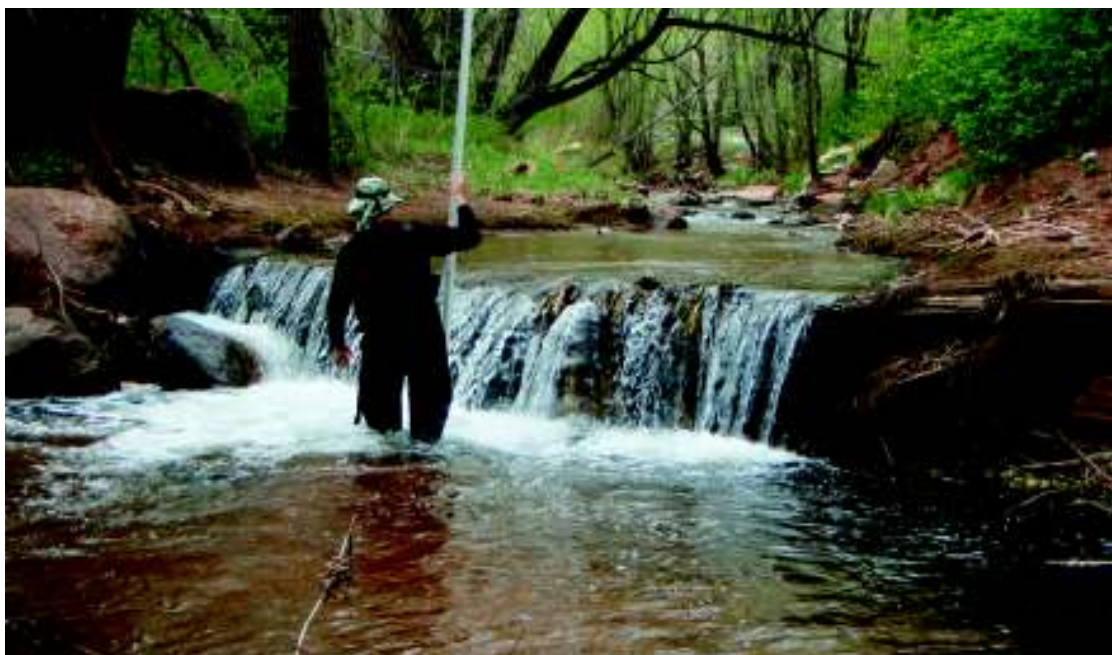
Photo 3: Potential fish barrier on Reach 2 - The Fields Park.

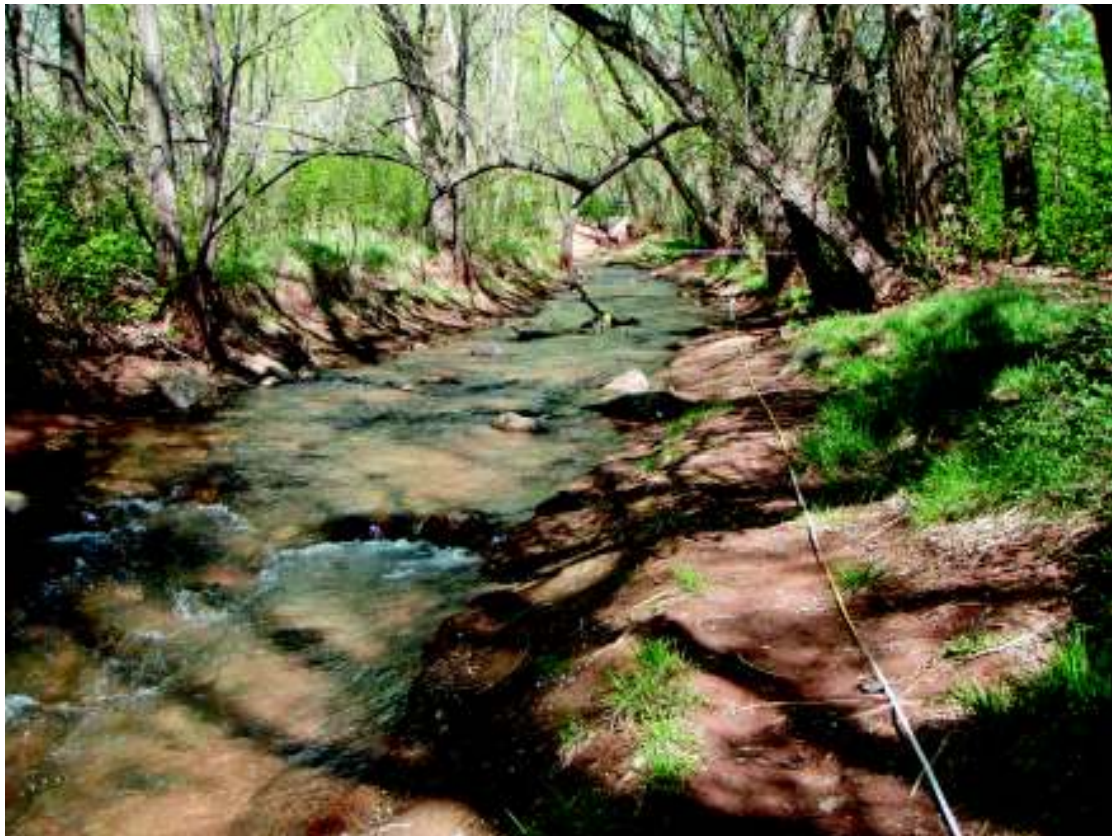
Photo 3: Lower half of The Fields Park project reach, looking upstream.

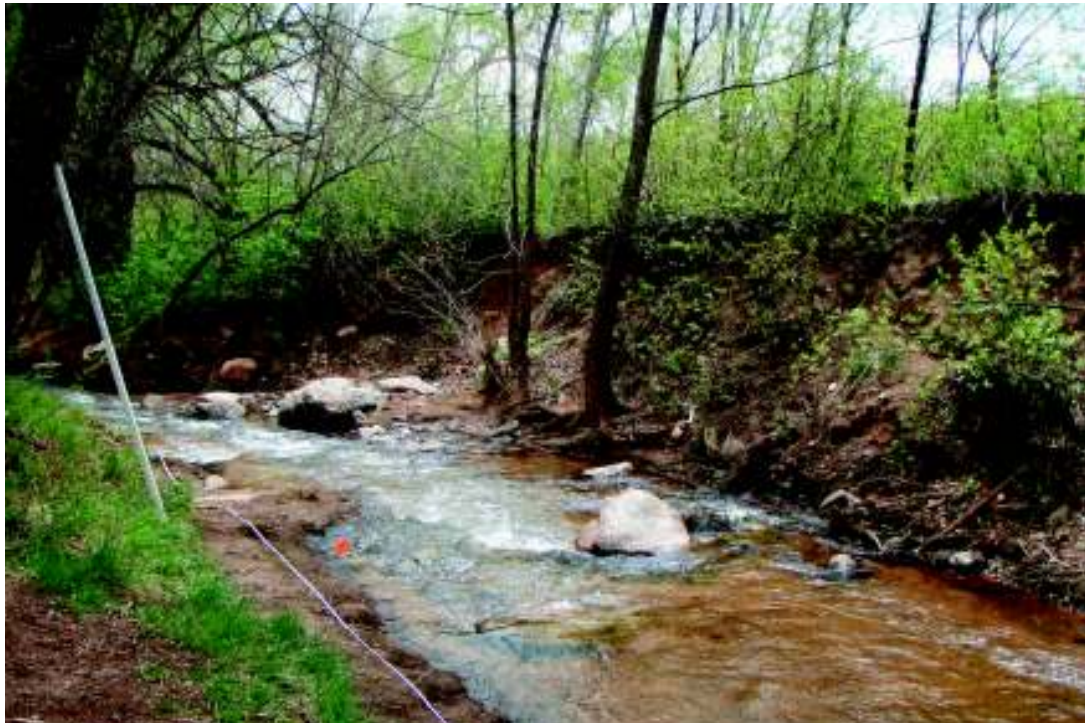
Stream bank stability was generally fair to poor in the reach, depending on vegetation composition degree of recreation use along any particular stream bank. Generally well vegetated stream banks were found on the side of the stream opposite of The Fields Park. Several areas of actively eroding stream banks were observed, particularly along the side of the stream adjacent to the park, and in the upstream half of the reach where the channel is more deeply entrenched. Forty-eight percent of the left bank and 63% of the right bank were found to be stable. The remaining 52% of the left bank and 37% of the right bank were found to be generally unstable and at risk of failure due to high flow shear forces on the banks (Chart 9). Bank rock content in the reach is shown in Chart 10, and consisted principally of gravel and smaller fragments (Type 8). Smaller fragments of less than 1/8"

were the most dominant type, indicating that the stream banks are more susceptible to erosion due to high flows than other reaches already assessed in Manitou Springs.

Photo 5: Eroding Stream Bank near the center of The Fields Park Reach 2.

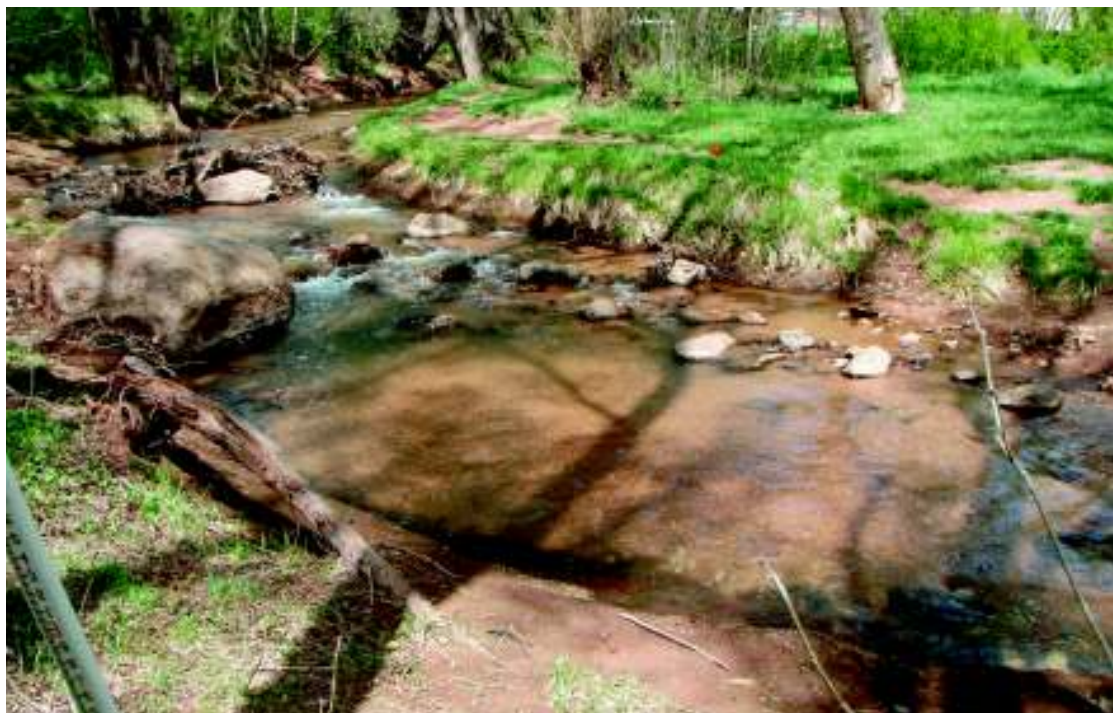
Aquatic habitat conditions throughout Reach 2 were generally very poor. Limiting factors to the fishery appear to be excessive sedimentation due to sediment from s upstream areas and contributing tributaries, resulting in poor quality pool habitat, and limited in-channel object cover in both the low gradient and pocket water riffles. Several problem areas were identified during the course of the inventory that should be addressed in order to alleviate potential worsening problems and loss of habitat, as well as to help the river achieve its full potential as a cold water fishery.

Photo 6: Typical poorly formed pool habitat - The Fields Park Reach 2.
